Manhole Inspection Summary

Manhole # S65E__009MH

Insp Date: **3/17/08 11:41 AM**

Location Address: **301 Cornwall St.**

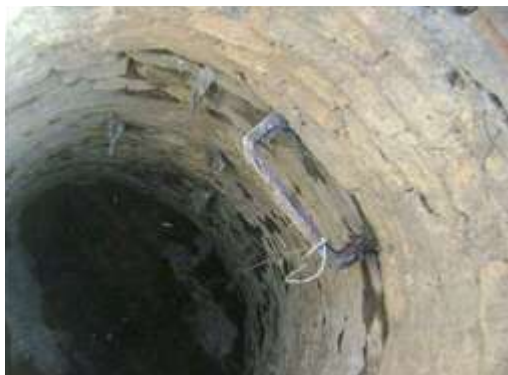
Defect 2

Infiltration: ☐ None ☐ Joint ☐ Cracks ☒ **Mortar** ☐ Roots ☒ **Wall**

Infiltration in barrel

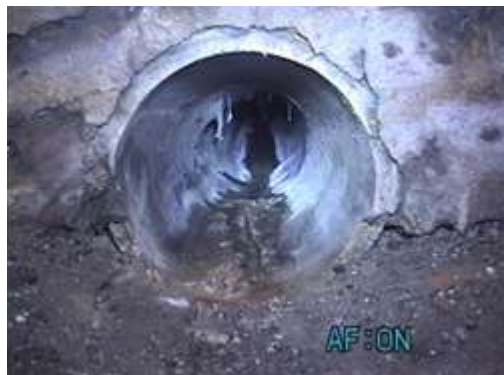
Defect 3

Fracture circumferential 4:00-6:00

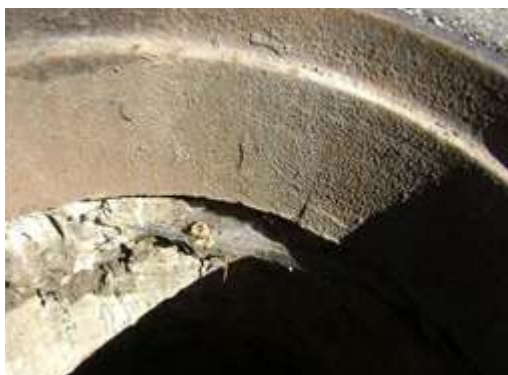
Defect 1

Condition: ☐ Sound ☐ Cracked ☐ Root Intrusion ☒ **Loose Brick** ☒ **Deteriorated**

Infiltration: ☐ None ☒ **Joint** ☐ Cracks ☒ **Mortar** ☐ Roots ☒ **Wall**

Loose/missing bricks in chimmney

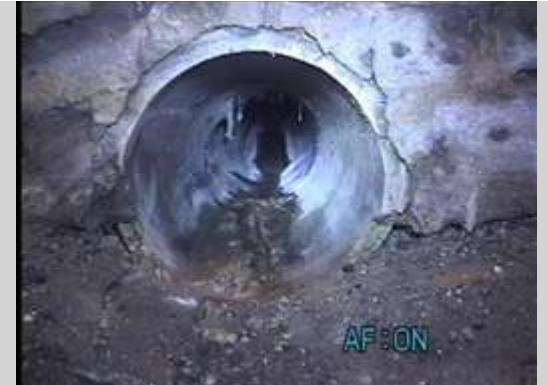
12 O'Clock Outflow

Deposits: ☐ None ☒ **Mud** ☐ Sludge ☒ **Debris** ☐ Grease

Silt Depth: **3** (in.) Deposits Extent: **Medium**
